## Robinson Helicopter Company Accident Report

AIRCRAFT MODEL:	<u>R44 Clipper I</u>
SERIAL NUMBER:	<u>1295</u>
REGISTRATION:	<u>N7530R</u>
ACCIDENT DATE:	<u>30 January 2018</u>
ACCIDENT LOCATION:	<u>Newport Beach, California</u>
NTSB IDENTIFICATION:	<u>WPR18FA077</u>

REPORT WRITTEN BY: Ken Martin

DATE: 17 June 2019

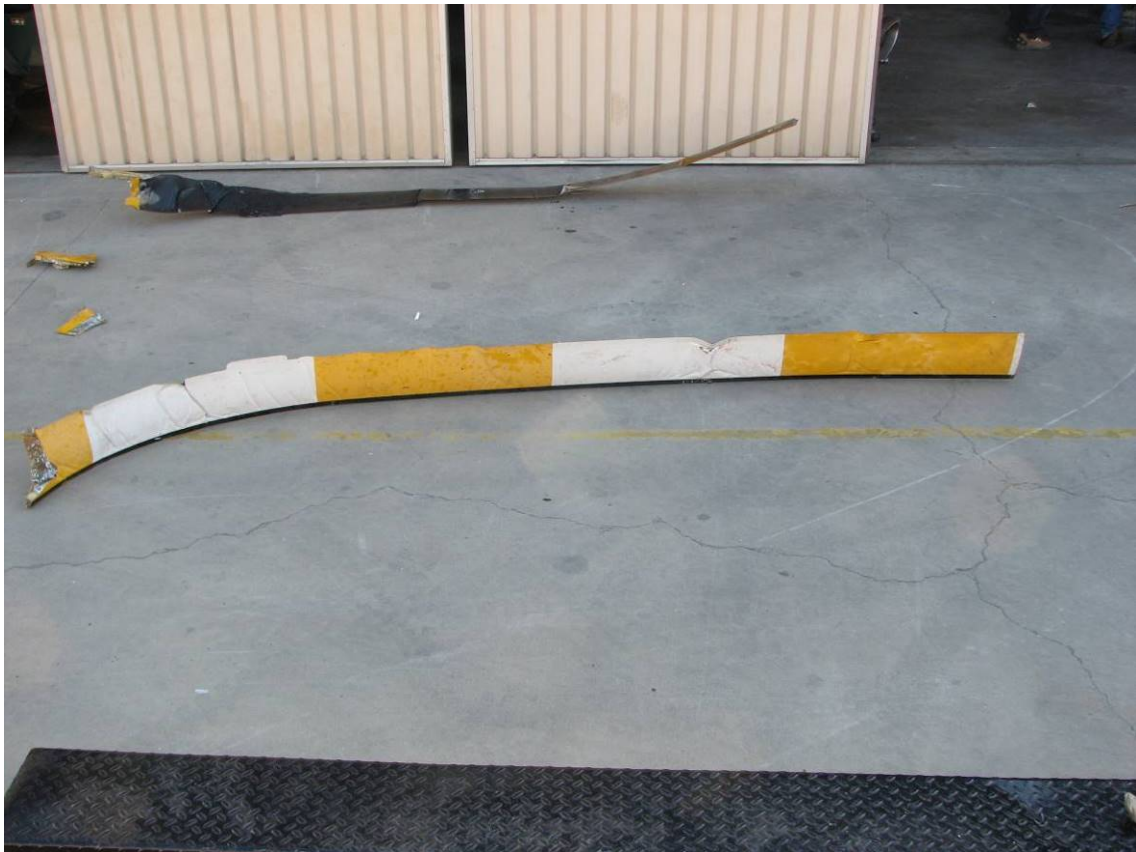
Main rotor blade SN 7870 at the accident site

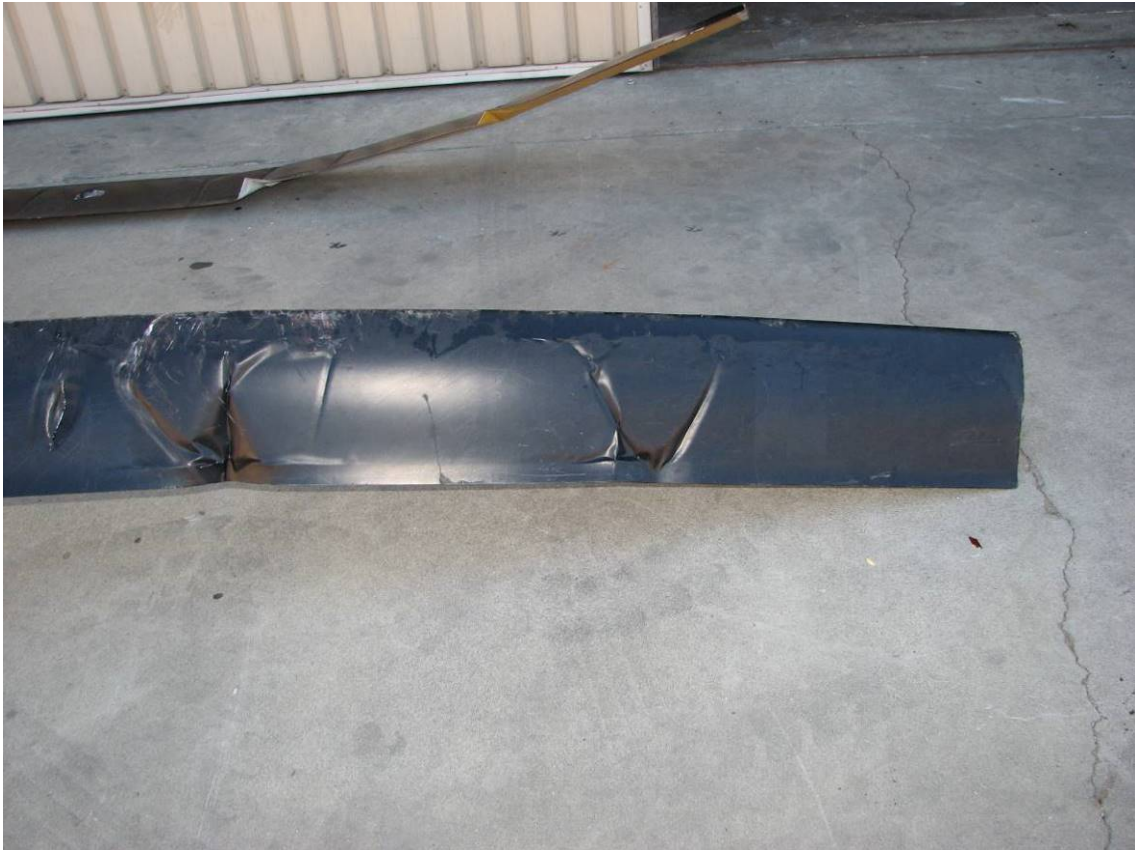
Main rotor blade SN 7870 after recovery (at left in photo)

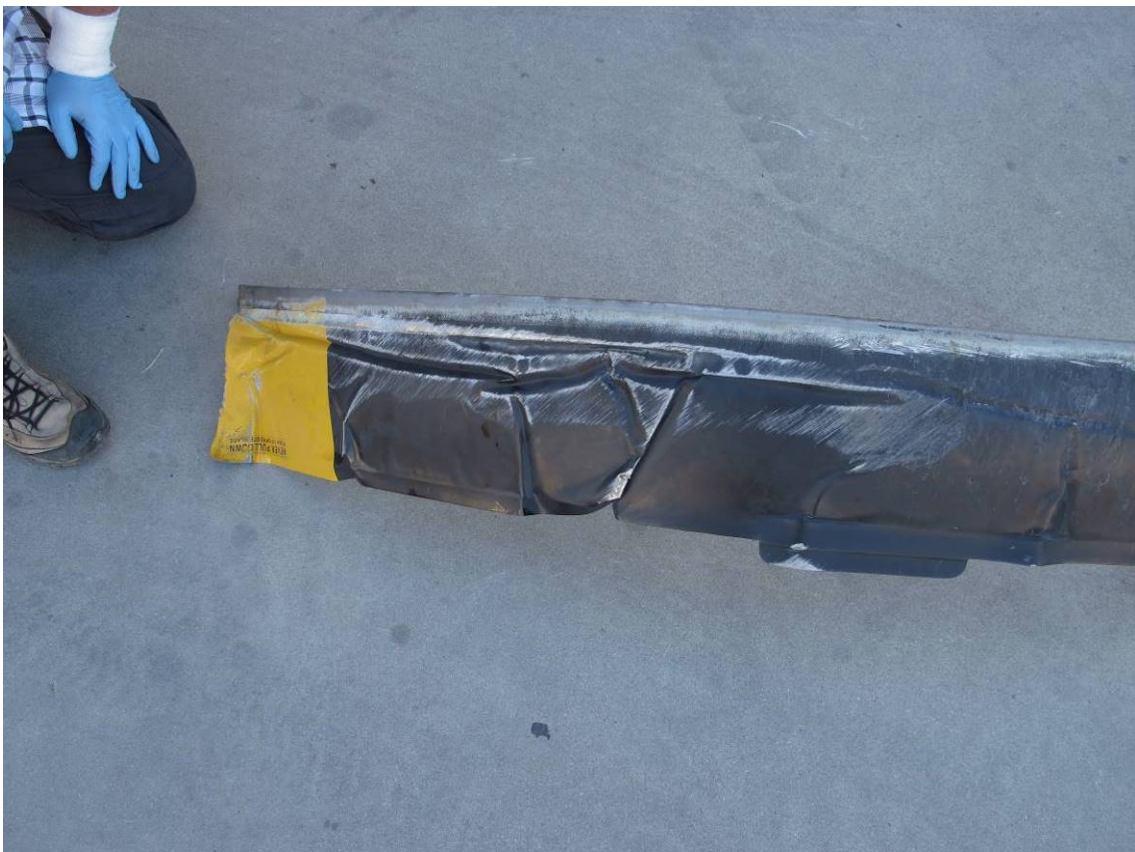
Main rotor blade SN 7870, lower surface, inboard section

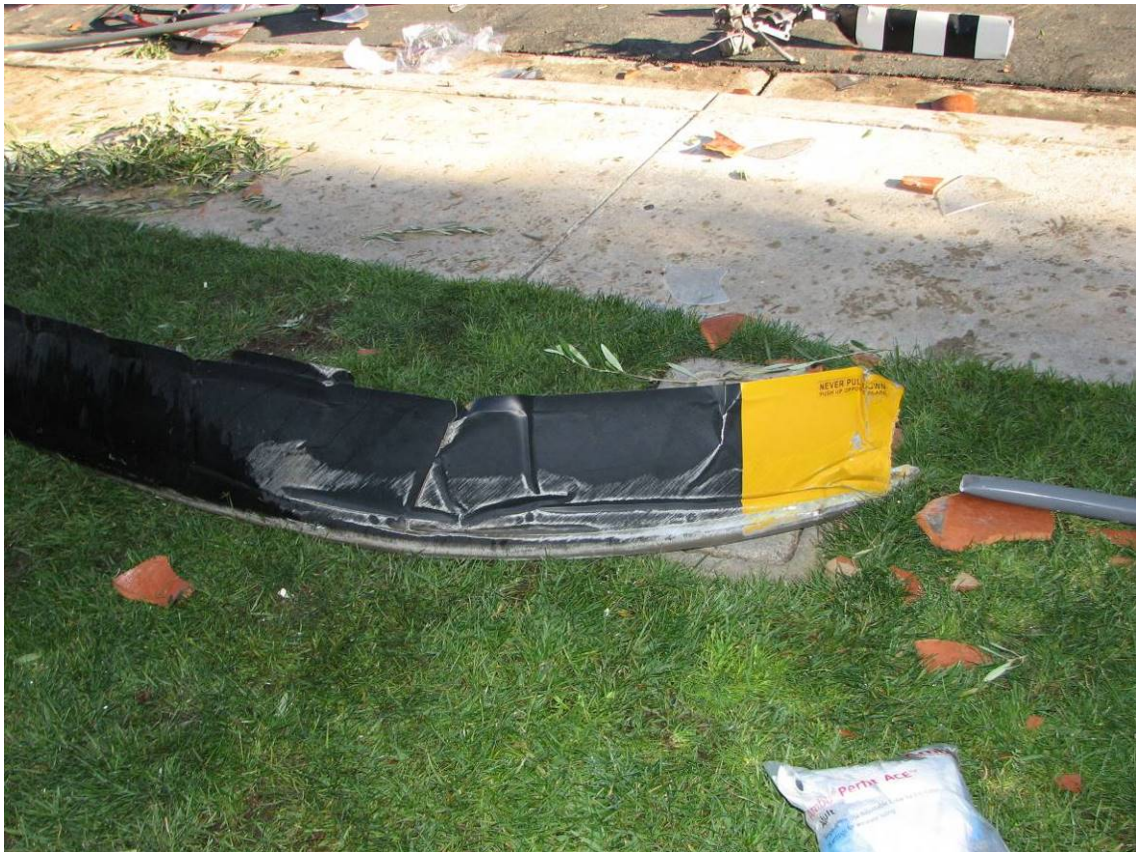
Main rotor blade SN 7870, lower surface, outboard section

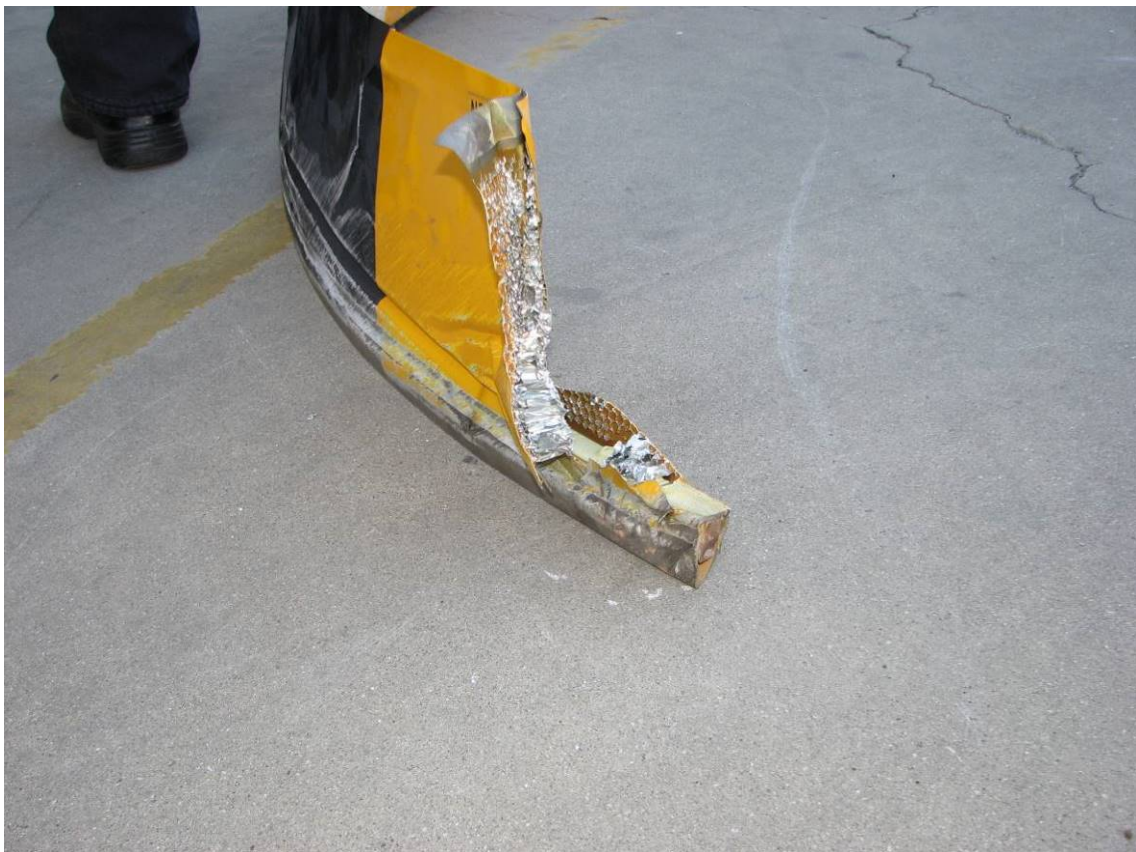
Main rotor blade SN 7870, lower surface, at tip

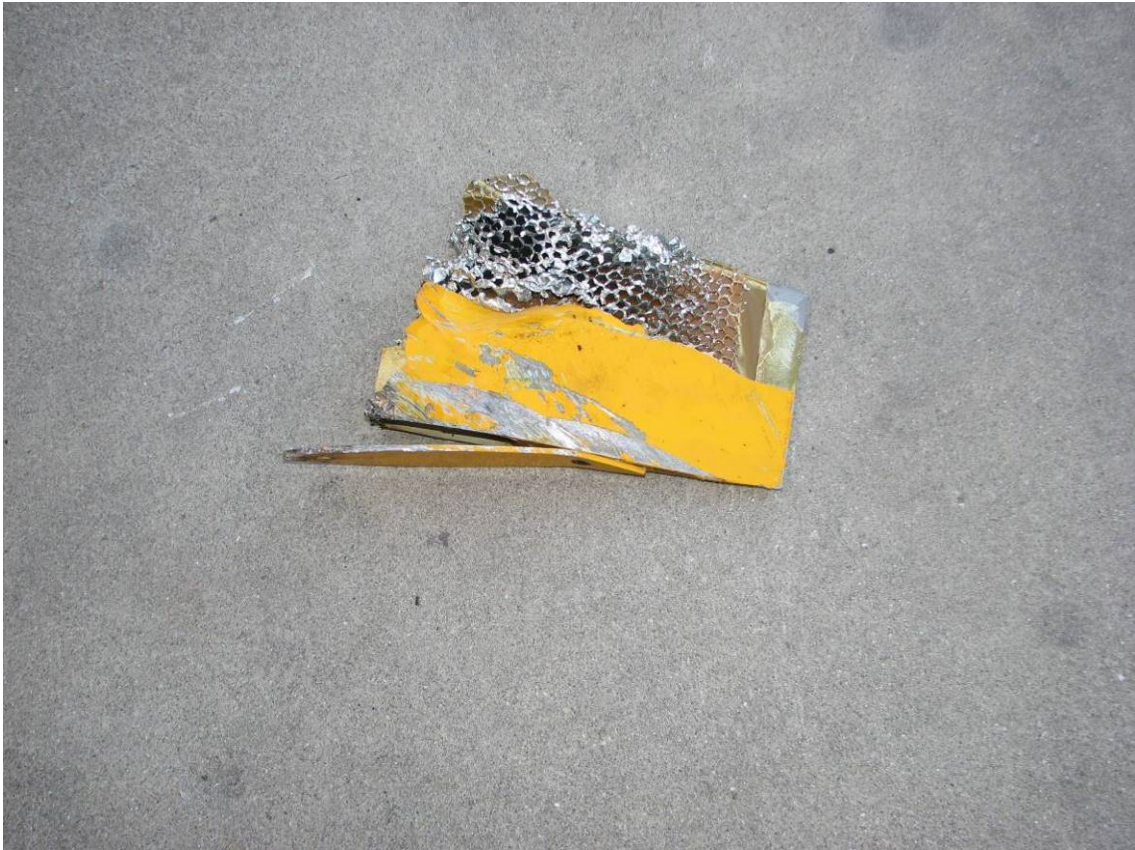
Main rotor blade SN 7870. Lower surface, at tip

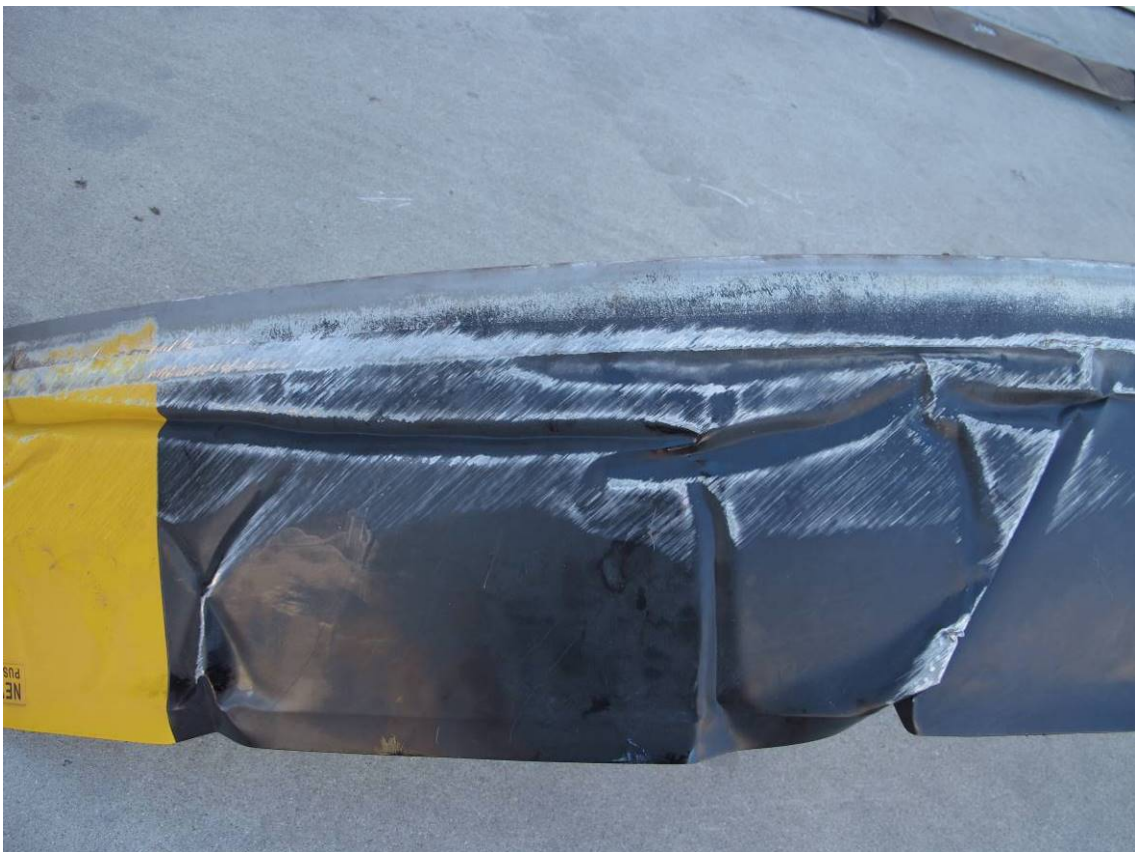
Main rotor blade SN 7870, lower surface of detached section at tip

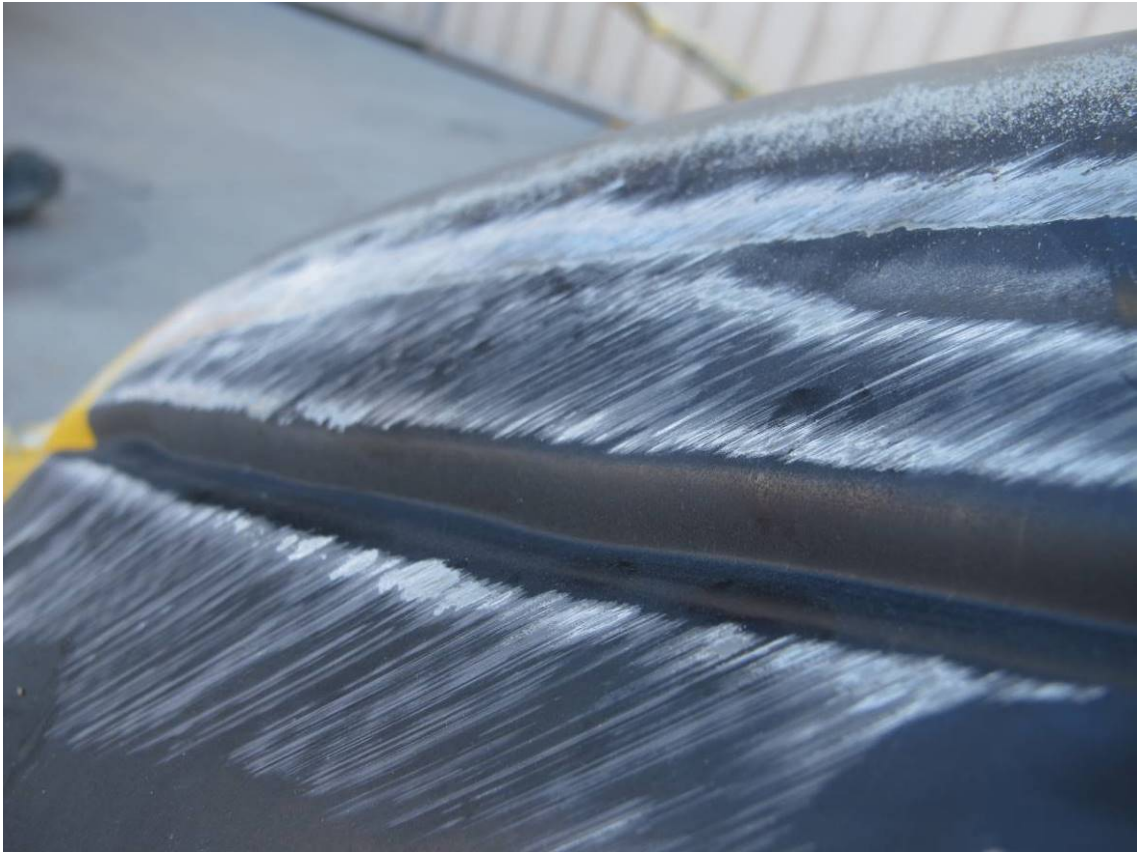
Scoring on main rotor blade SN 7870 lower surface, near tip

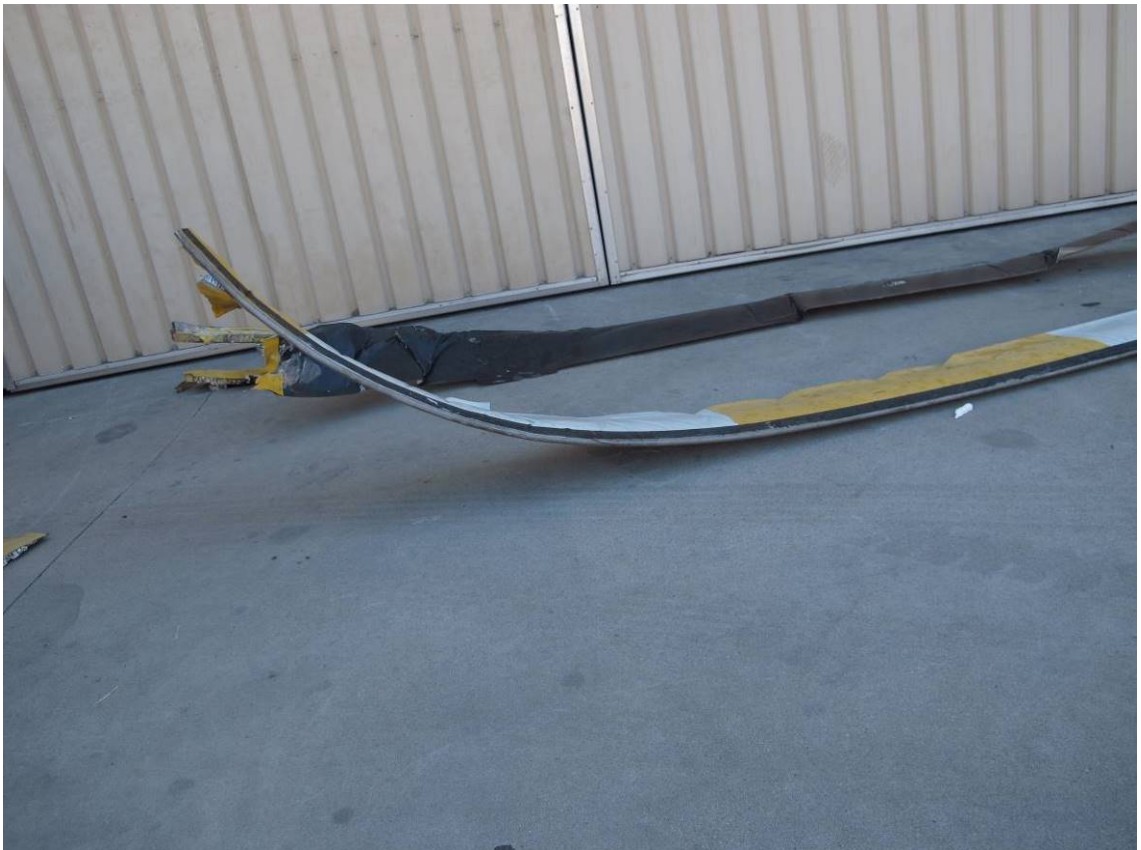
Scoring on main rotor blade SN 7870 lower surface, near tip

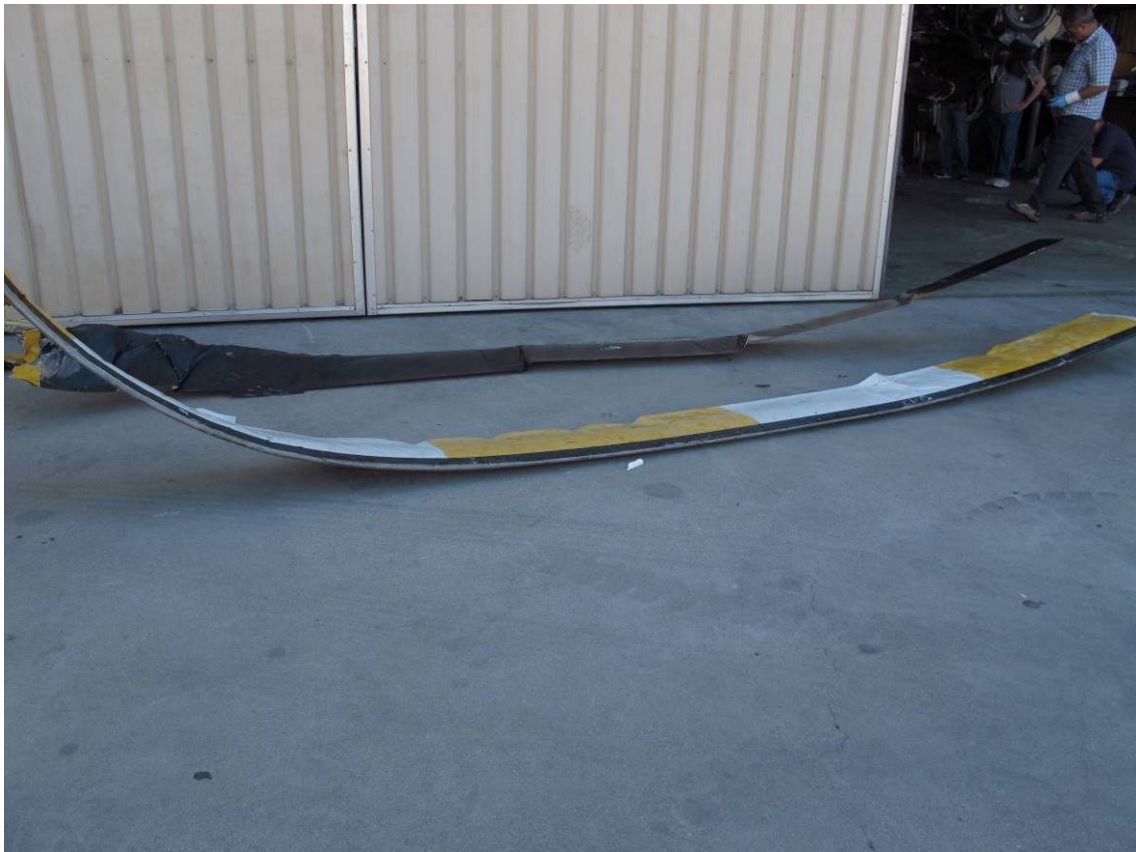
Leading edge of main rotor blade SN 7870, (in foreground in photo)

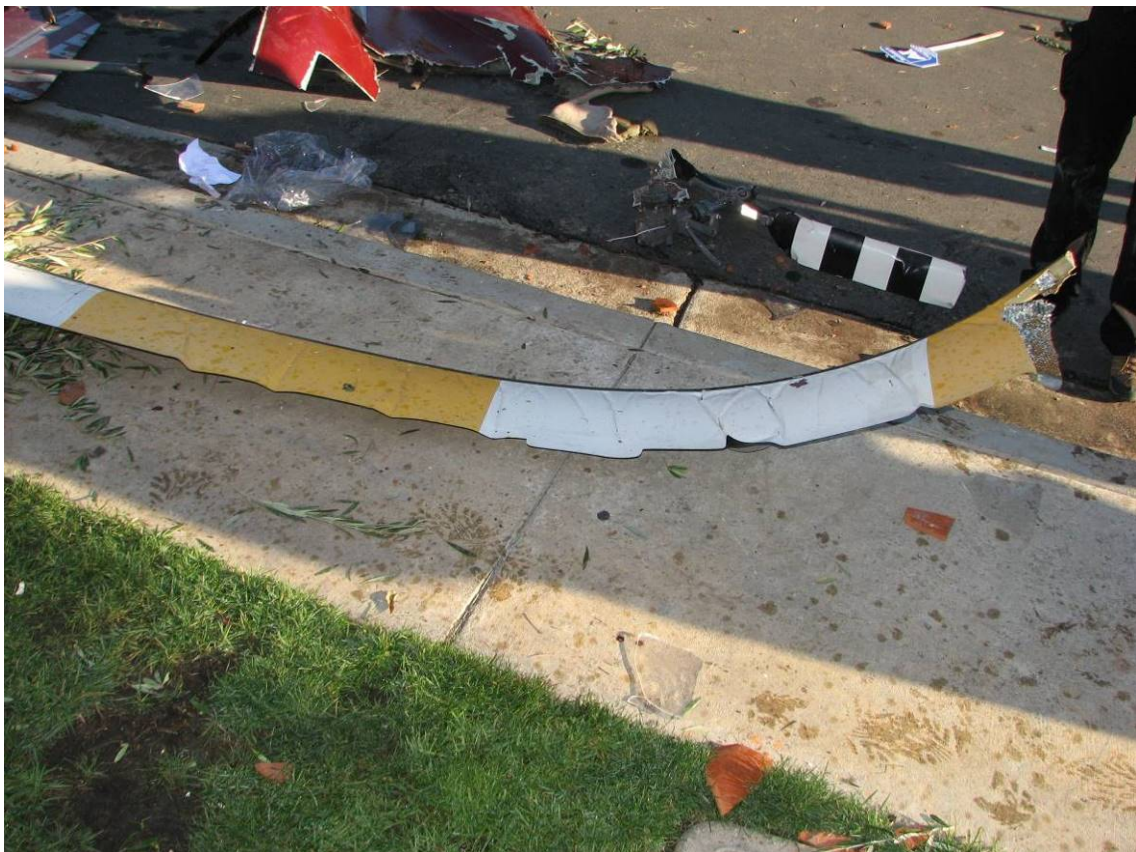
Leading edge of main rotor blade SN 7870, (in foreground in photo)

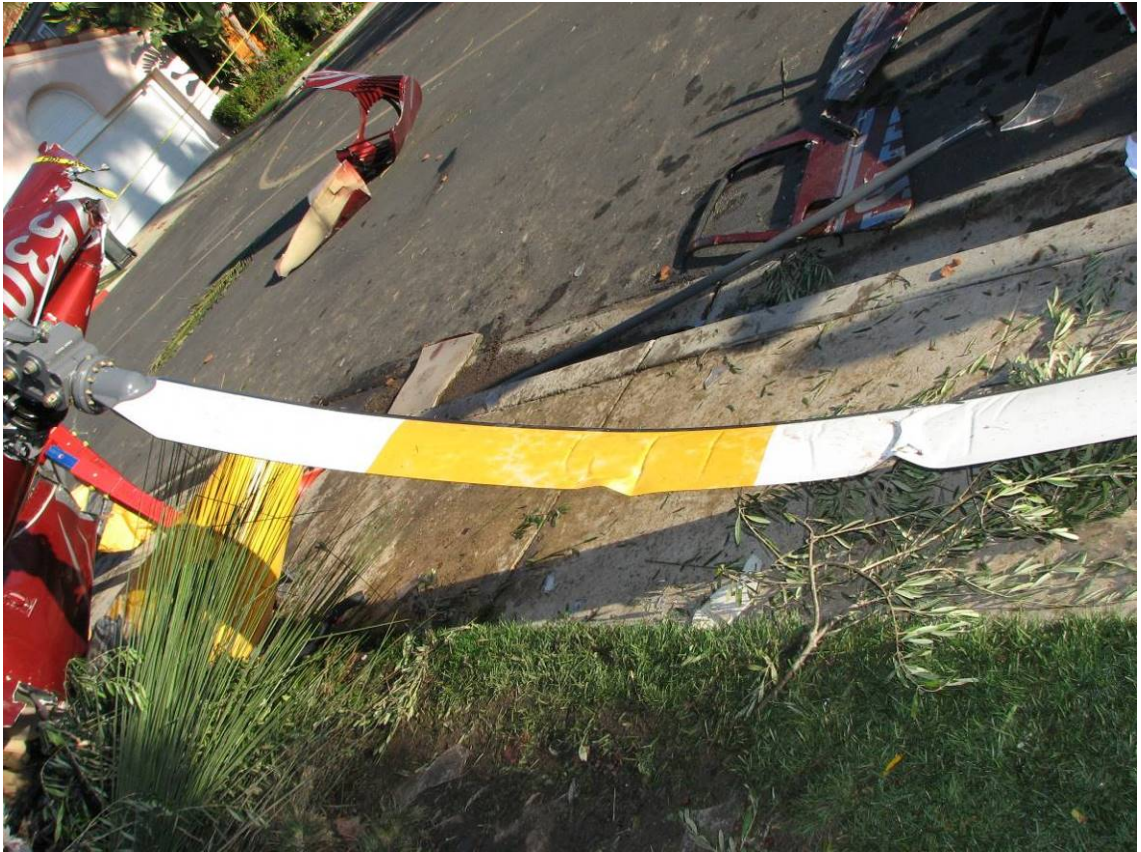
Upper surface of main rotor blade SN 7870

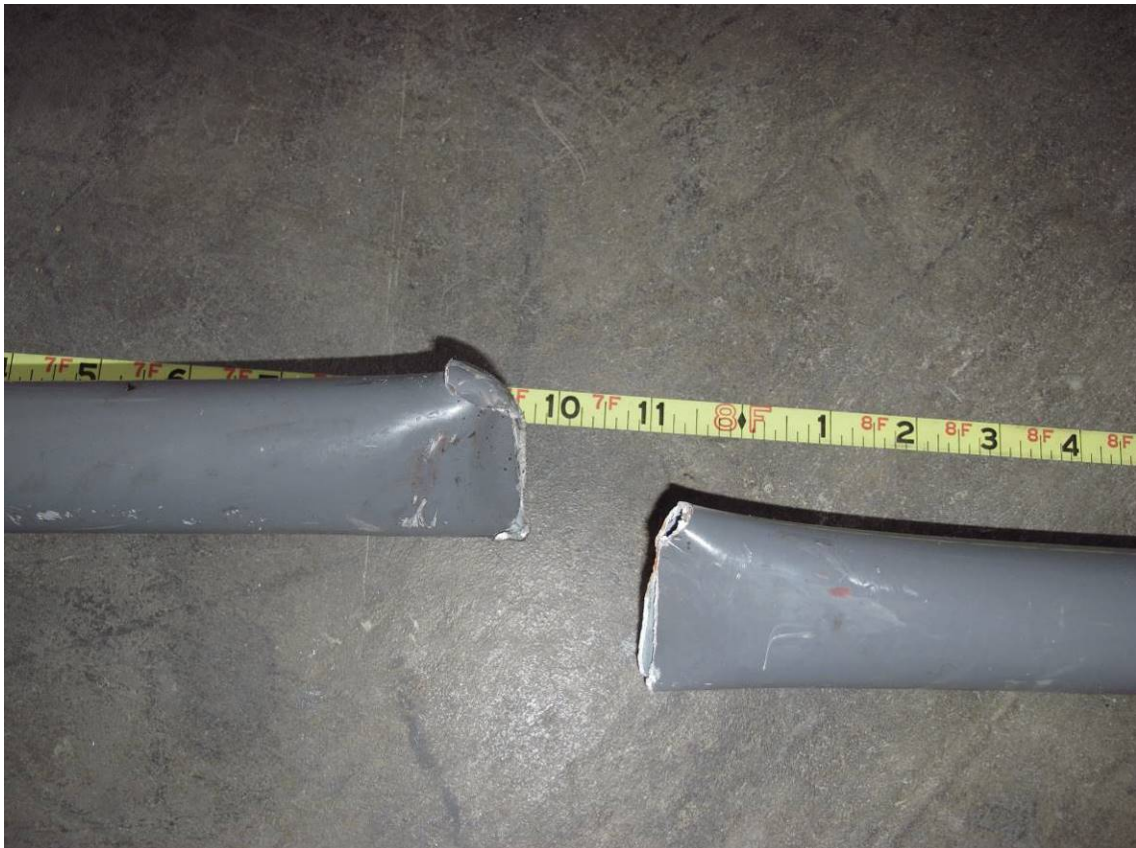
The forward separation of the tail rotor driveshaft

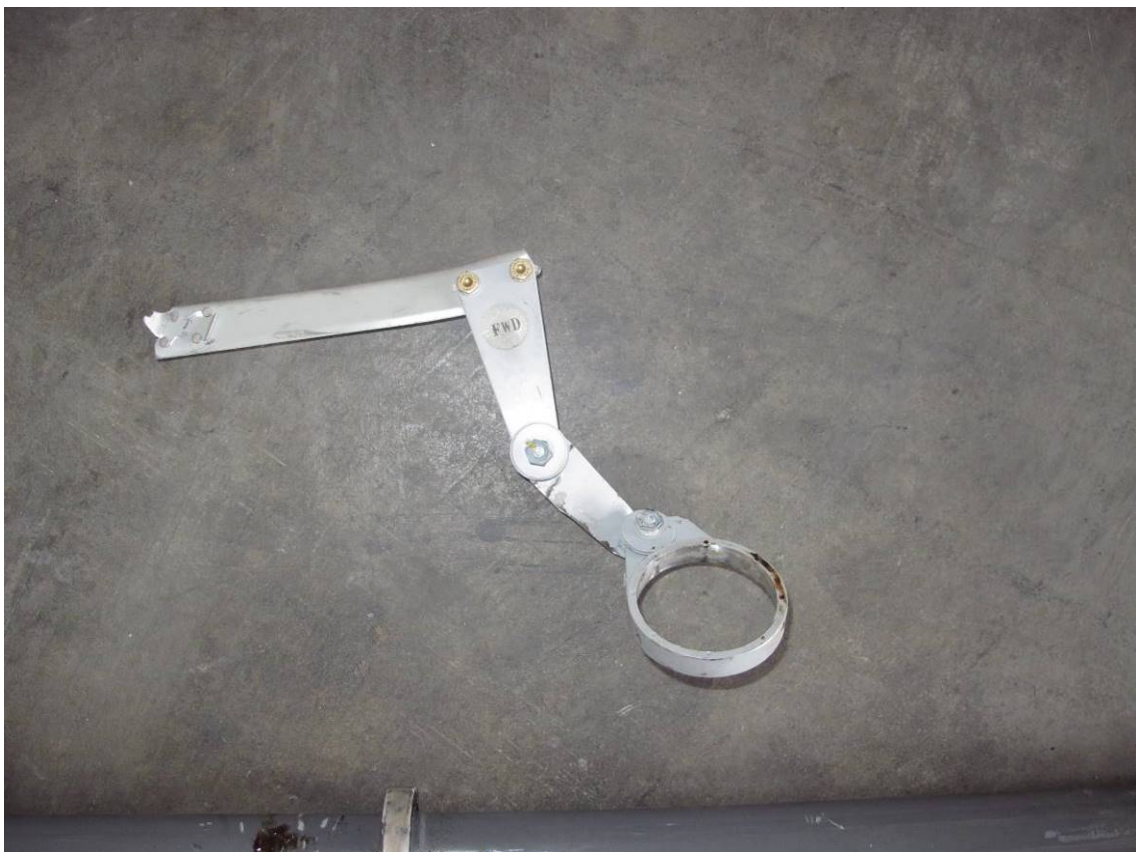
The aft separation of the tail rotor driveshaft

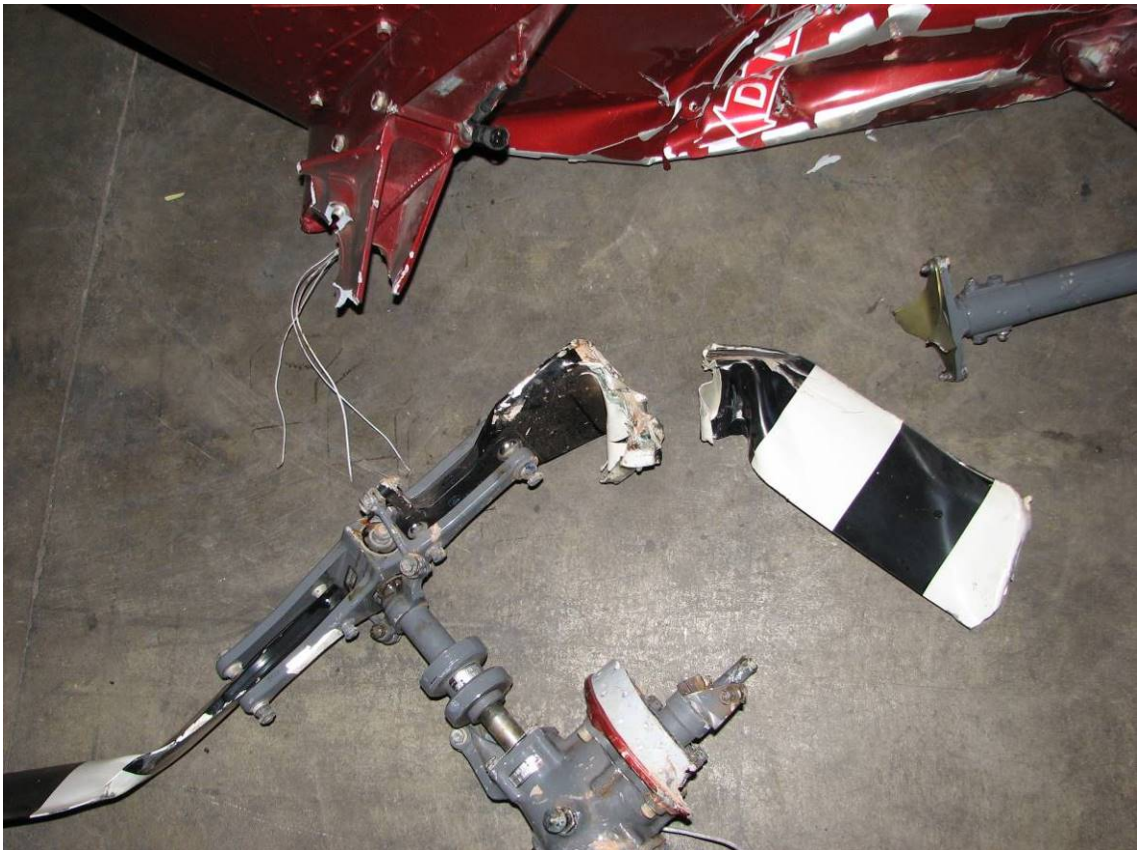
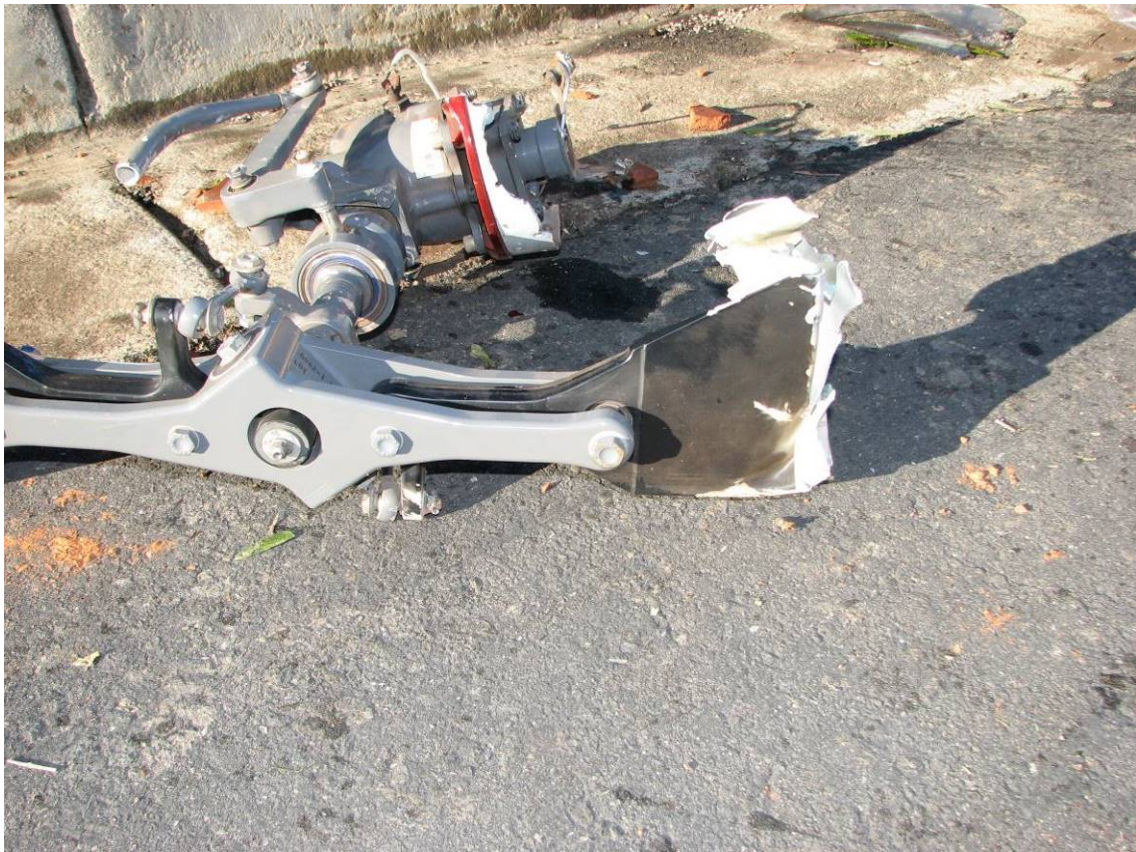
The tail rotor

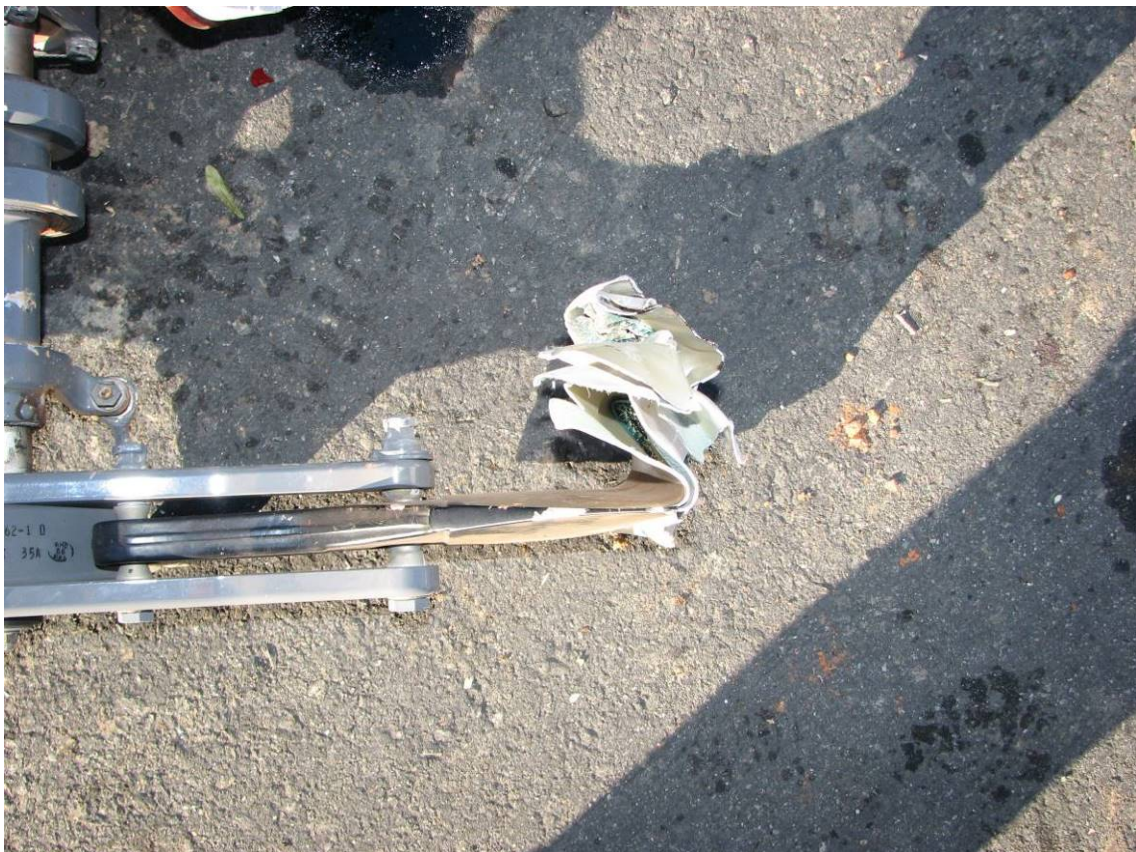
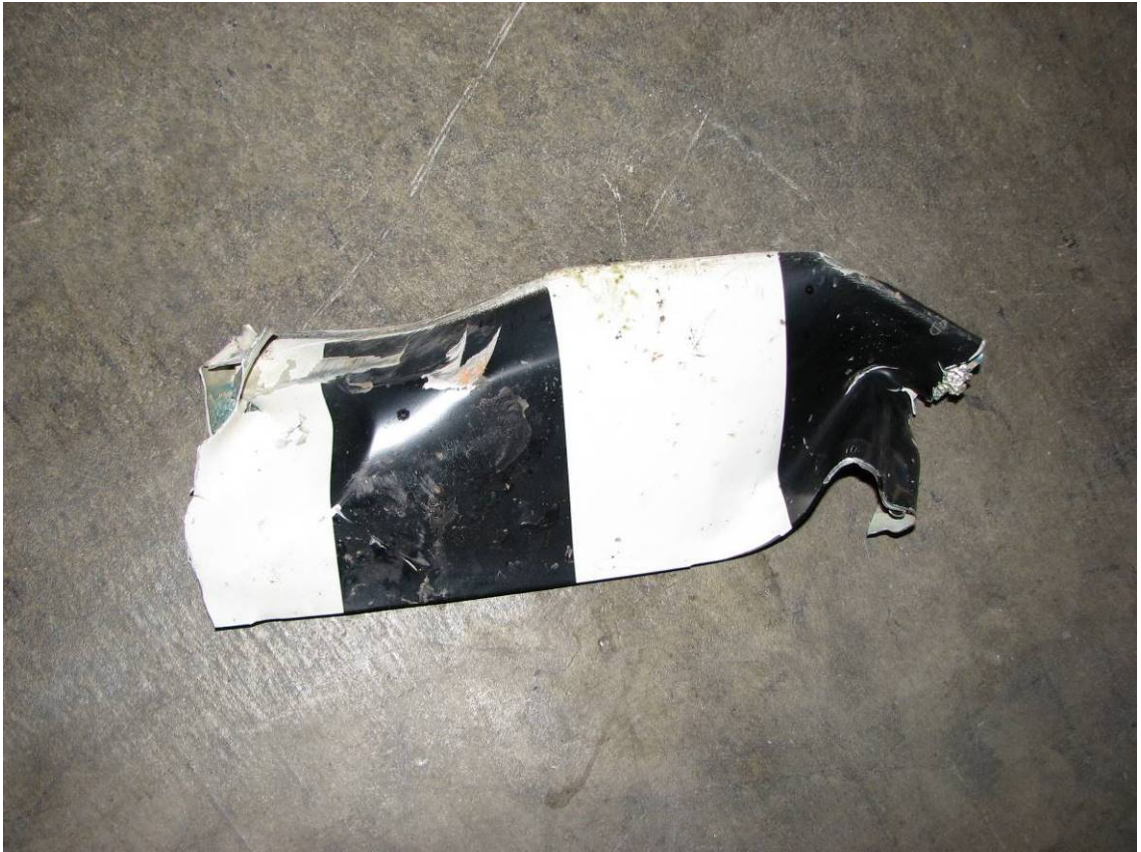
The inboard portion of tail rotor blade SN 2330

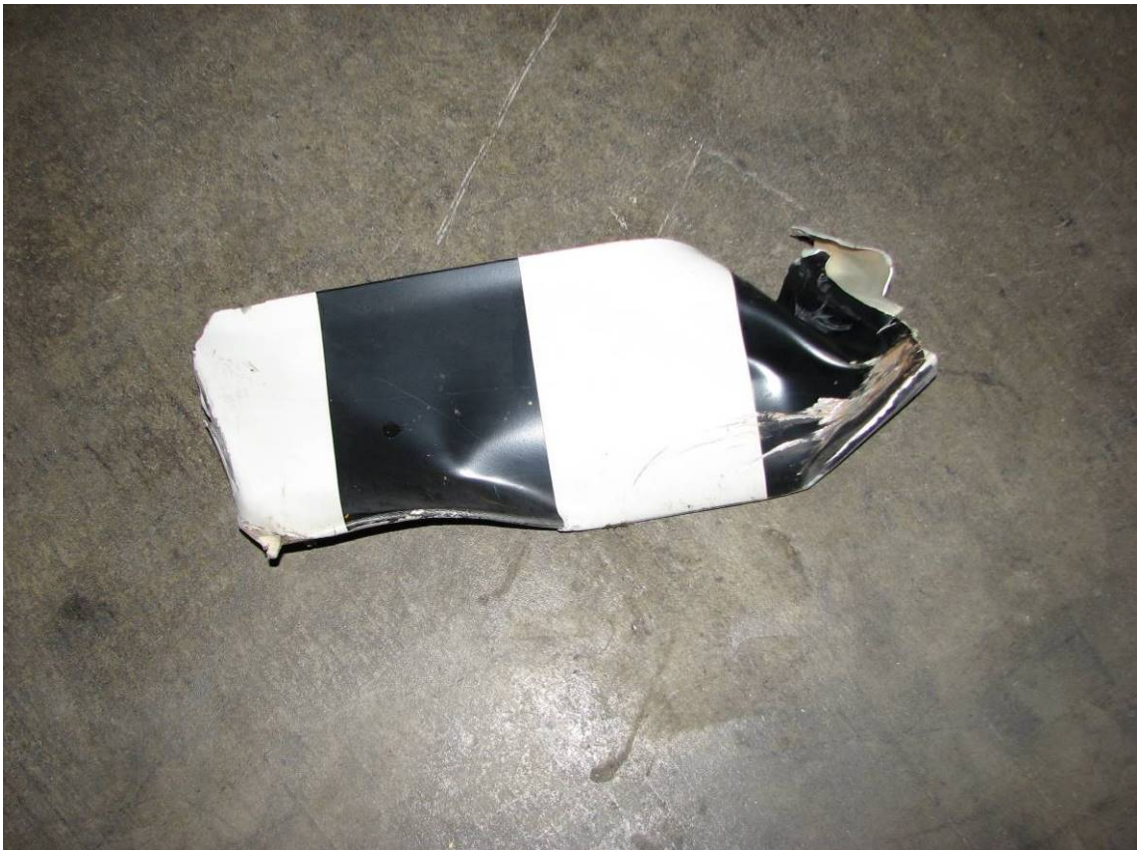
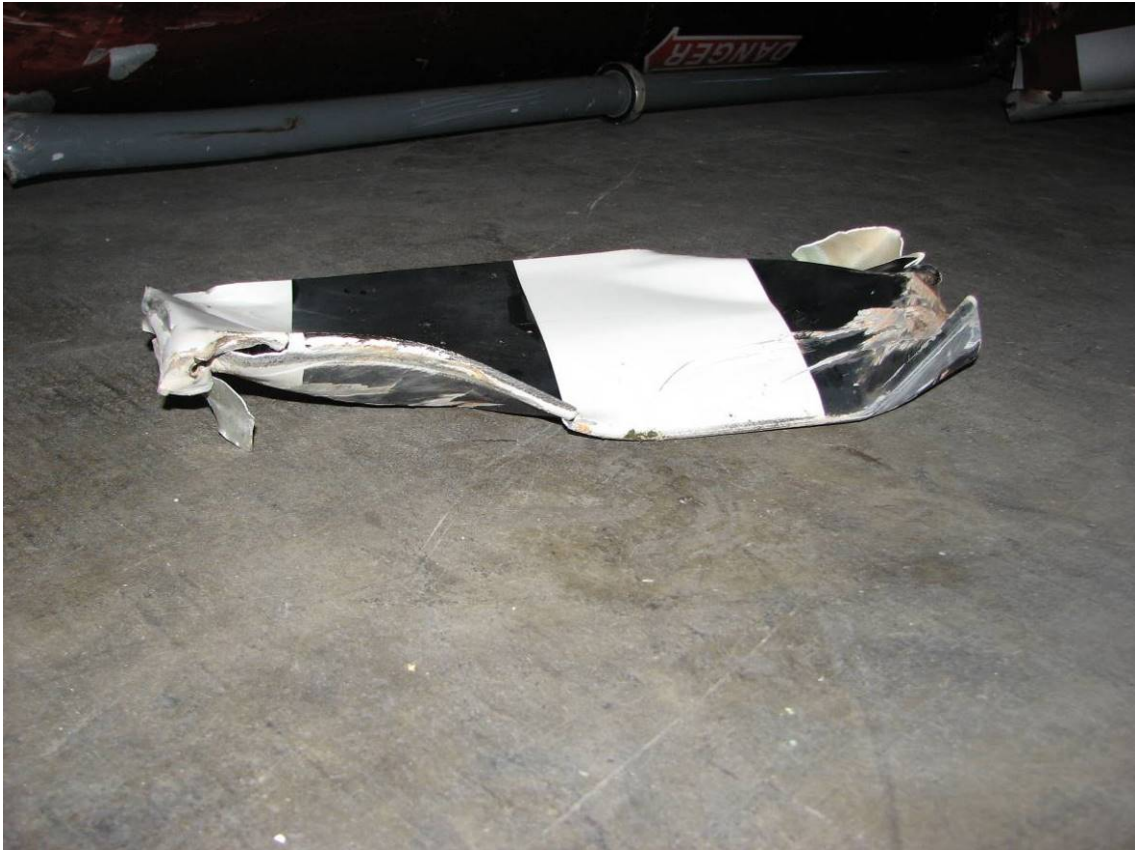
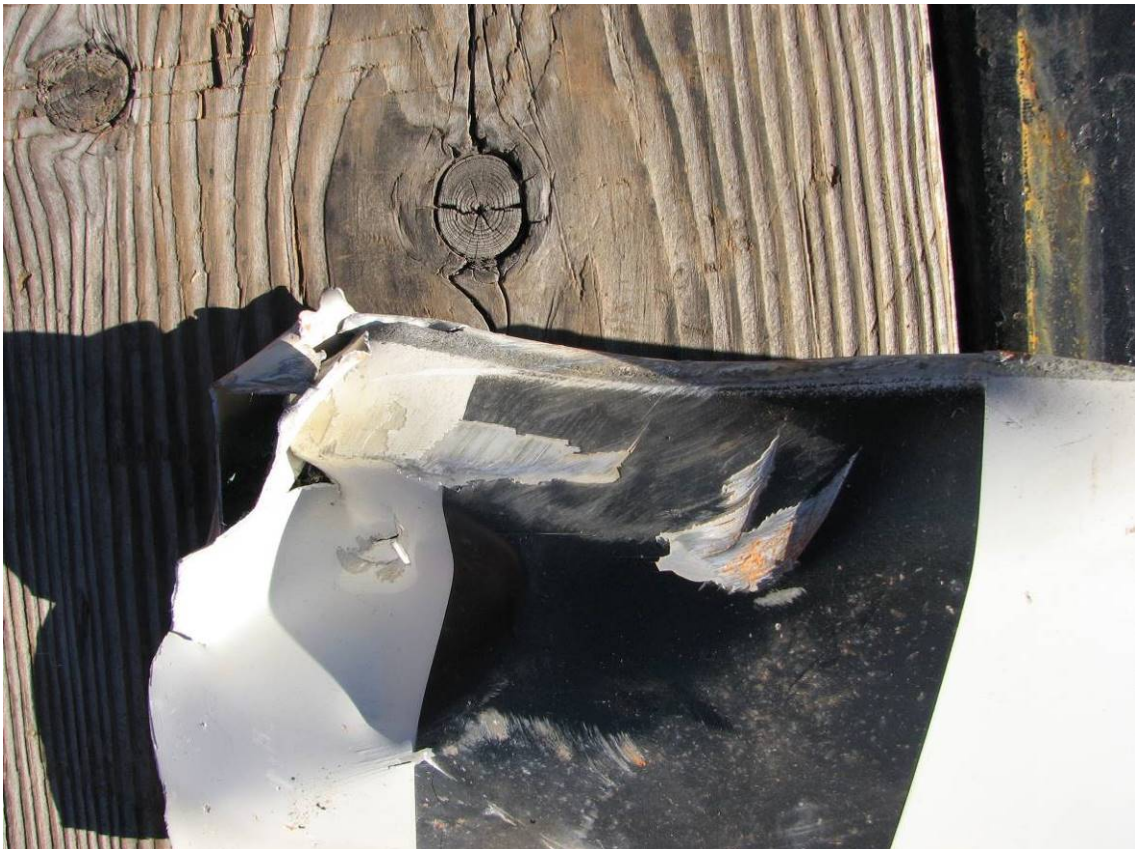
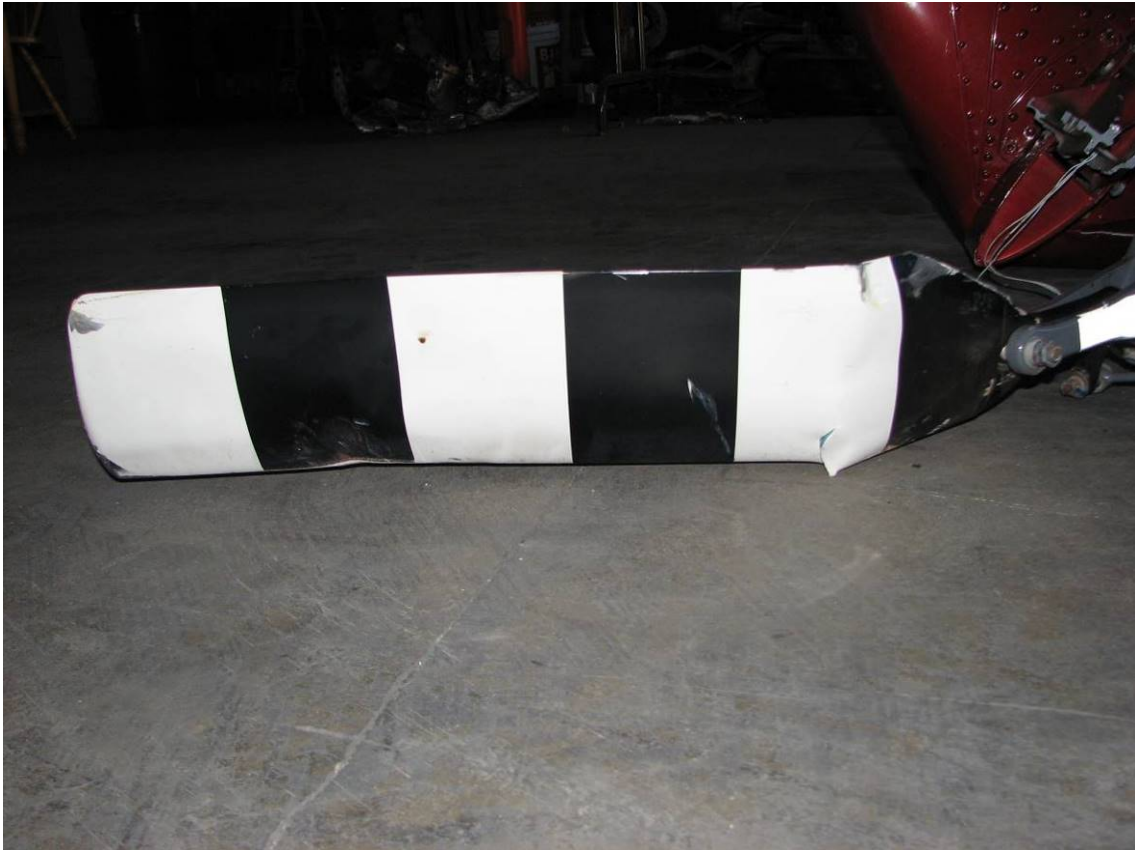
The center portion of tail rotor blade SN 2330

Above and below: The center portion of tail rotor blade SN 2330
